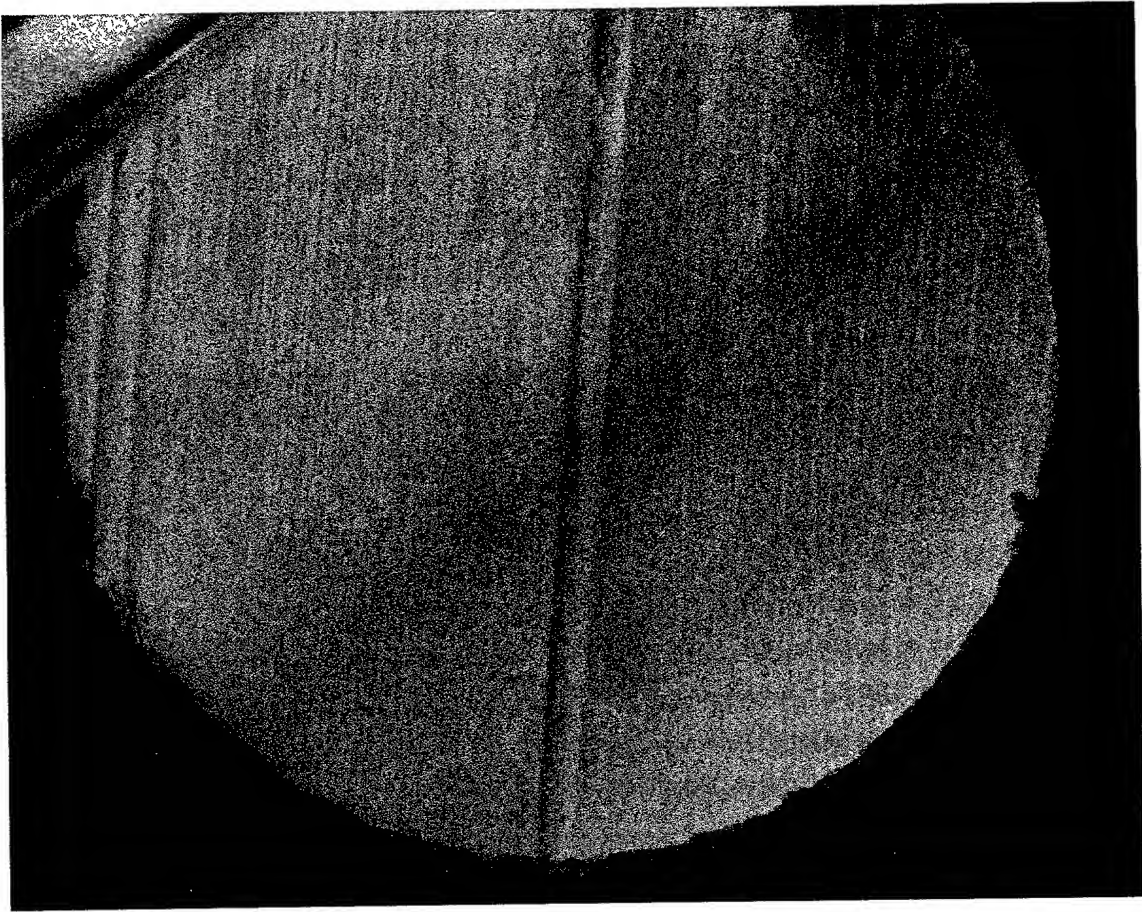
Figure 1. A section of plasterboard was treated with a Mildew Shield. The presence of coating is visible under a black light.
